Clinical study with gradually anodized implants restored with two-piece anodized abutments – preliminary results

Background and Aim

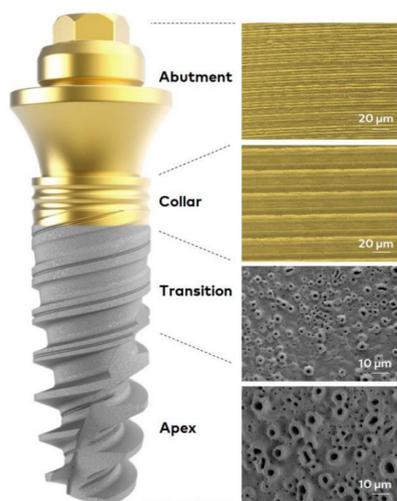
Figure 1
Implant system with the newly engineered surfaces (left) and low magnification SEM images of the surfaces at indicated regions.

Surface chemistry and topography of the implant-abutment complex play a key role in implant osseointegration and proper adhesion of the soft tissue to the restoration.¹ To optimize tissue integration at every level, novel anodized implant and abutment surfaces were developed. The implant surface has a gradual change in topography designed to promote early osseointegration and to support stable marginal bone, while the new surface at the tissue-level base promotes undisturbed mucointegration (Figure 1).²

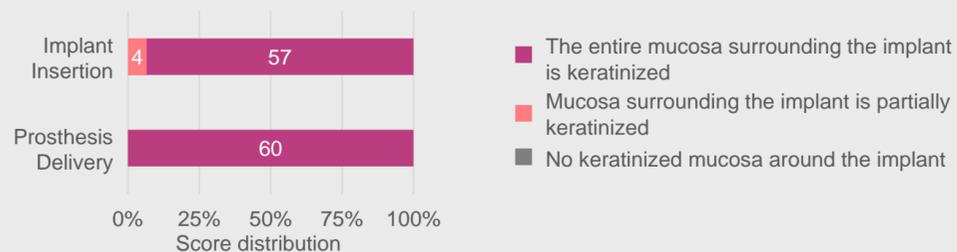
Keratinized mucosa status

Figure 2
Improvement in keratinized mucosa status from implant insertion to prosthetic delivery.

- **Healthy soft tissue** demonstrated by improved keratinized mucosa status (figure 2), low sulcus bleeding index: 51 sites (85%) showed no bleeding when a periodontal probe was passed along the gingival margin adjacent to the implant, and healthy gingiva with 56 sites (93%) showing no signs of inflammation surrounding the crown. 35 sites (58%) had no plaque, while 20 and 5 sites showed minimal and moderate plaque accumulation, respectively.
- **Excellent implant survival rate** of 100% and success rate of 96.6%.
- **Very high patient satisfaction** with function and esthetics (mean score of 9.9 and 9.8, respectively, on a scale of 0 to 10) and improved oral-related quality of life ($p=0.0420$) from pretreatment to final prosthesis delivery.

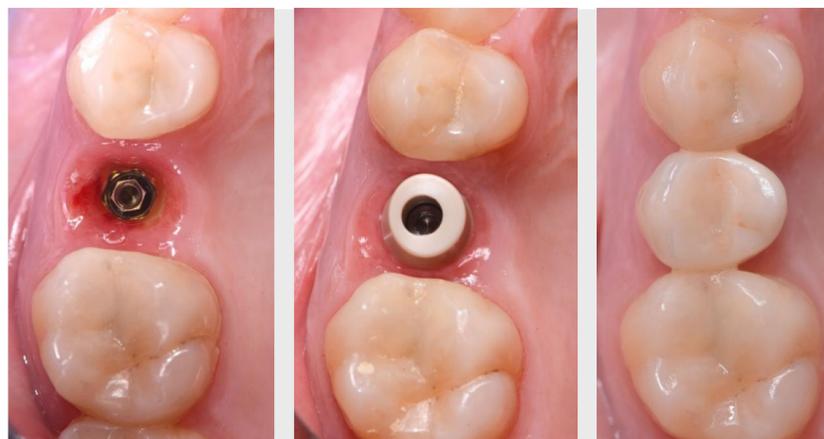
Figure 3
Left panel: Occlusal view of the soft tissue healing and maturation 10 weeks after the surgery. Middle panel: Prosthetic finalization according to a fully digital workflow with the On1 IOS (intraoral scannable) healing cap. Right panel: final prosthesis in situ.

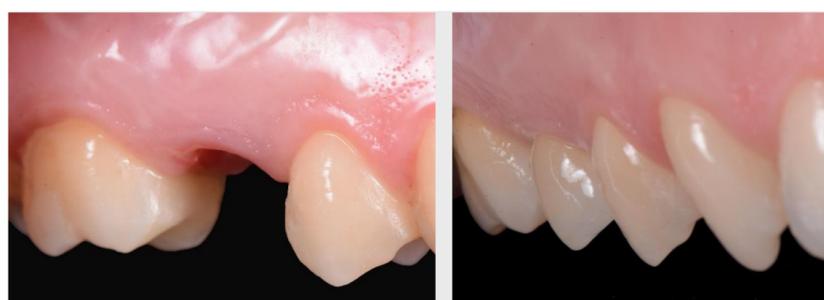
Figure 4
Left panel: Soft tissue health and quality on the day of the prosthetic delivery. Note the ideal soft tissue thickness and quality necessary to create optimal conditions to achieve an excellent esthetic outcome and long term stability. Right panel: Clinical view at the 6-month follow-up visit demonstrating the biological and esthetic integration.
